TECHNICAL REPORT HL-90-18

RIO PUERTO NUEVO FLOOD-CONTROL PROJECT SAN JUAN, PUERTO RICO

Hydraulic Model Investigation

Prepared for US Army Engineer District, Jacksonville
Jacksonville, Florida 32232-0019

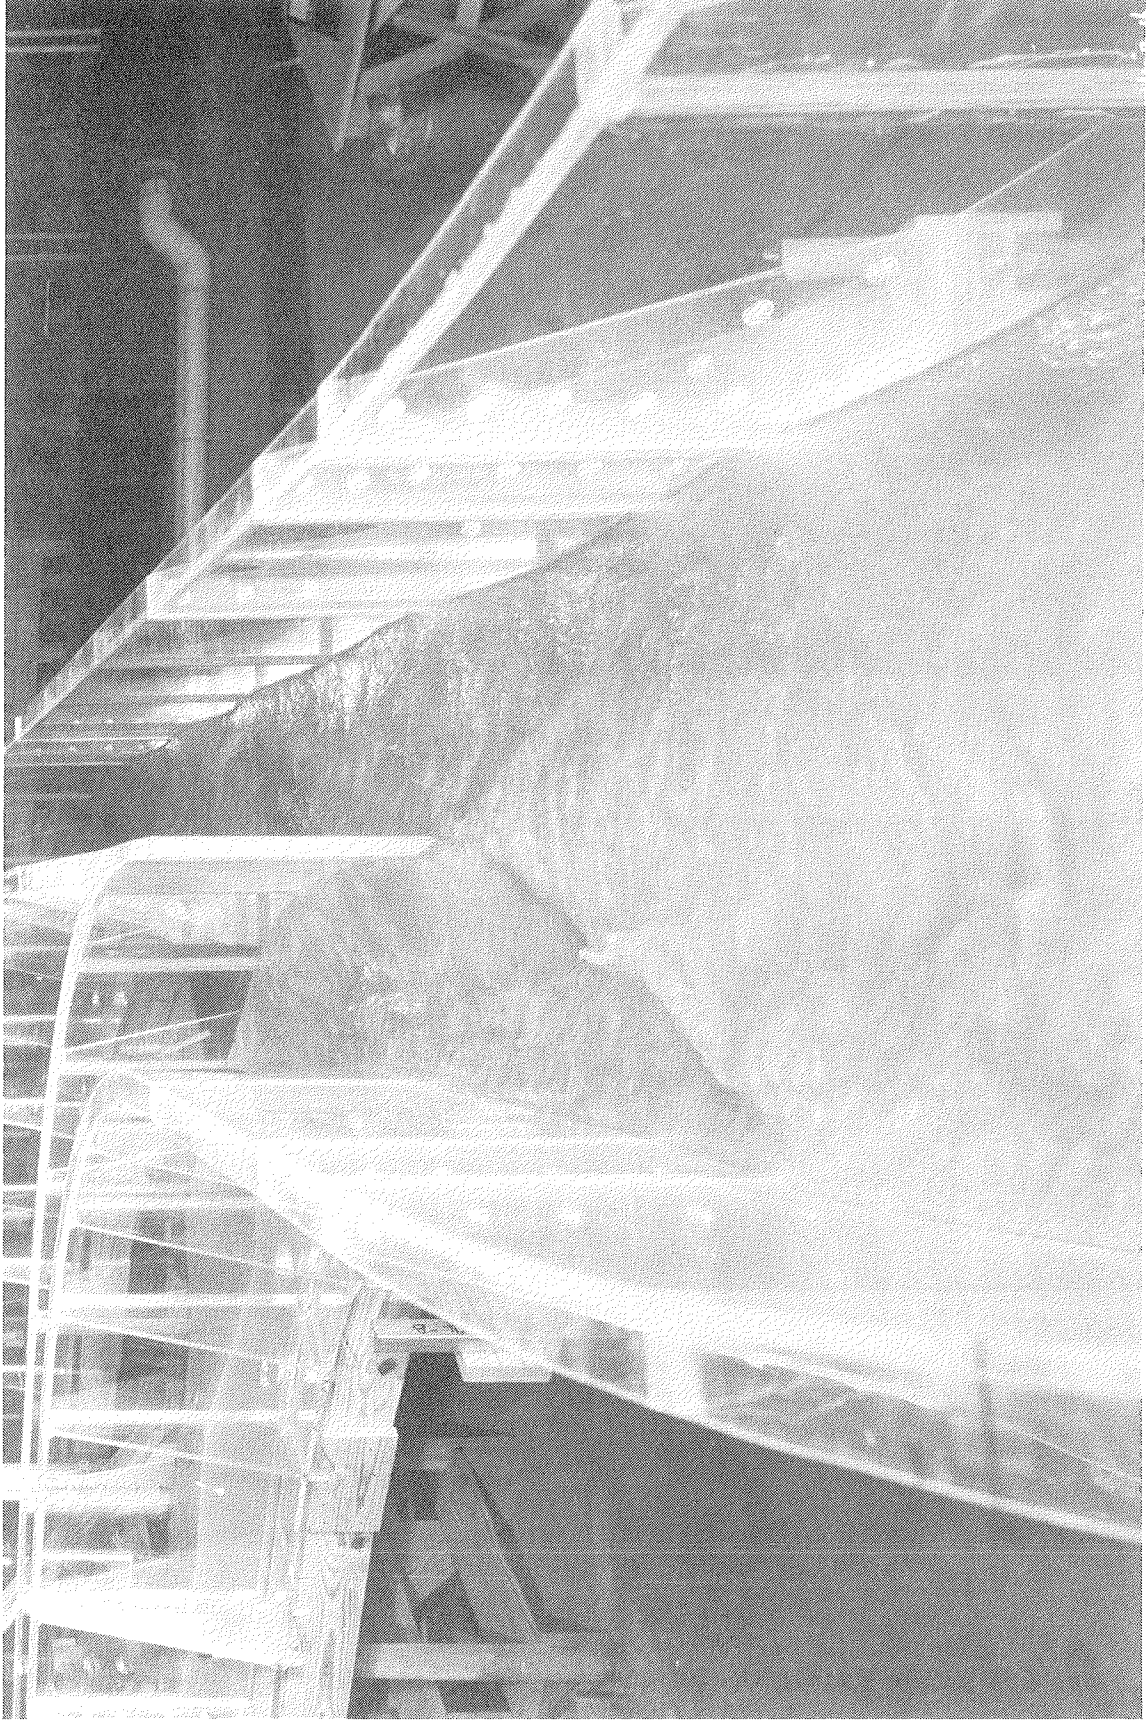
Photo 19. Flow conditions, Dona Ana-Josefina Channel confluence looking upstream,
Dona Ana discharge 5,641 cfs, Josefina discharge 5,627 cfs, $n = 0.015$

35. Photo 19 shows the confluence of the Dona Ana and Josefina Channels (looking upstream) with flow coming out of curve J5 with a prominent super-elevation of the water surface. Immediately downstream of the confluence divider wall, a stationary oblique standing wave (Photo 19) existed for all conditions tested. This standing wave caused no adverse effects to the flow in the channel and was accepted as satisfactory performance. Photo 20 shows flow going into curve J4 with a slight superelevation. Photo 21 shows the hydraulic jump at sta 15+50 in the Josefina Channel. The hydraulic jump formed uniformly across the channel.

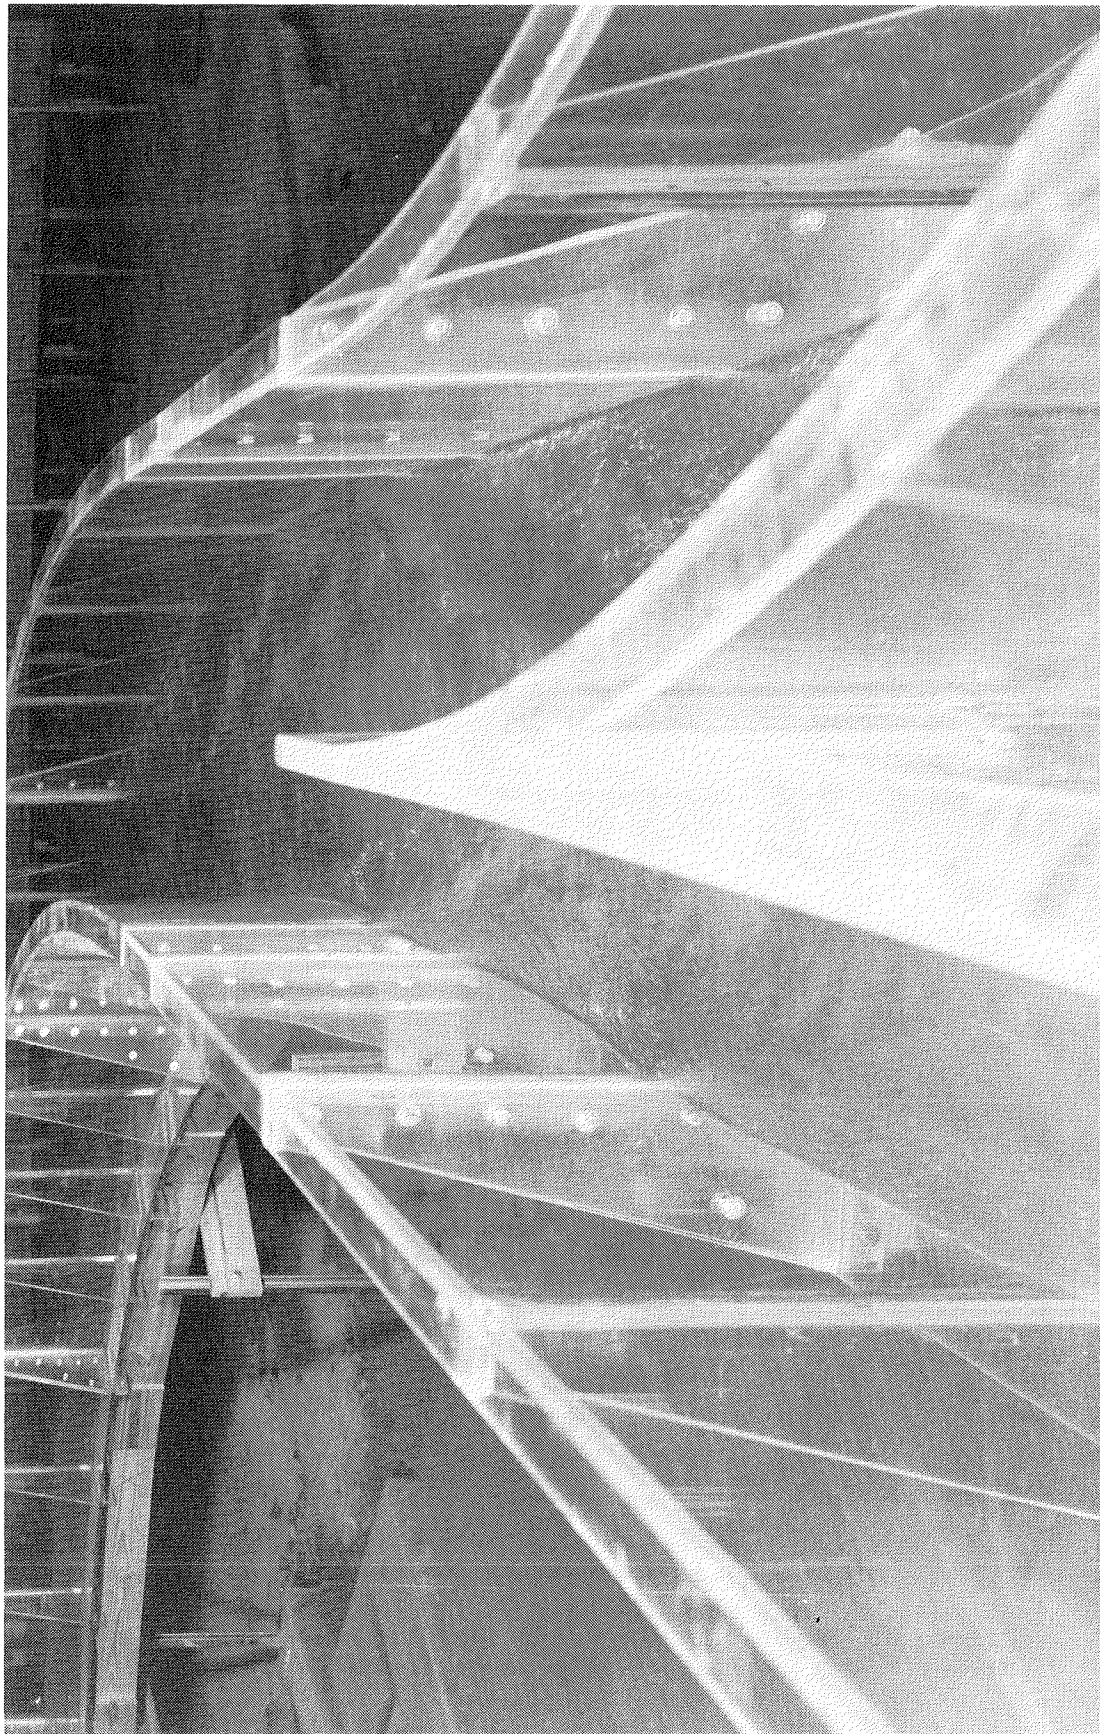
Photo 20. Flow conditions, Dona Ana-Josefina Channel confluence looking downstream,
Dona Ana discharge 5,641 cfs, Josefina discharge 5,627 cfs, $n = 0.015$

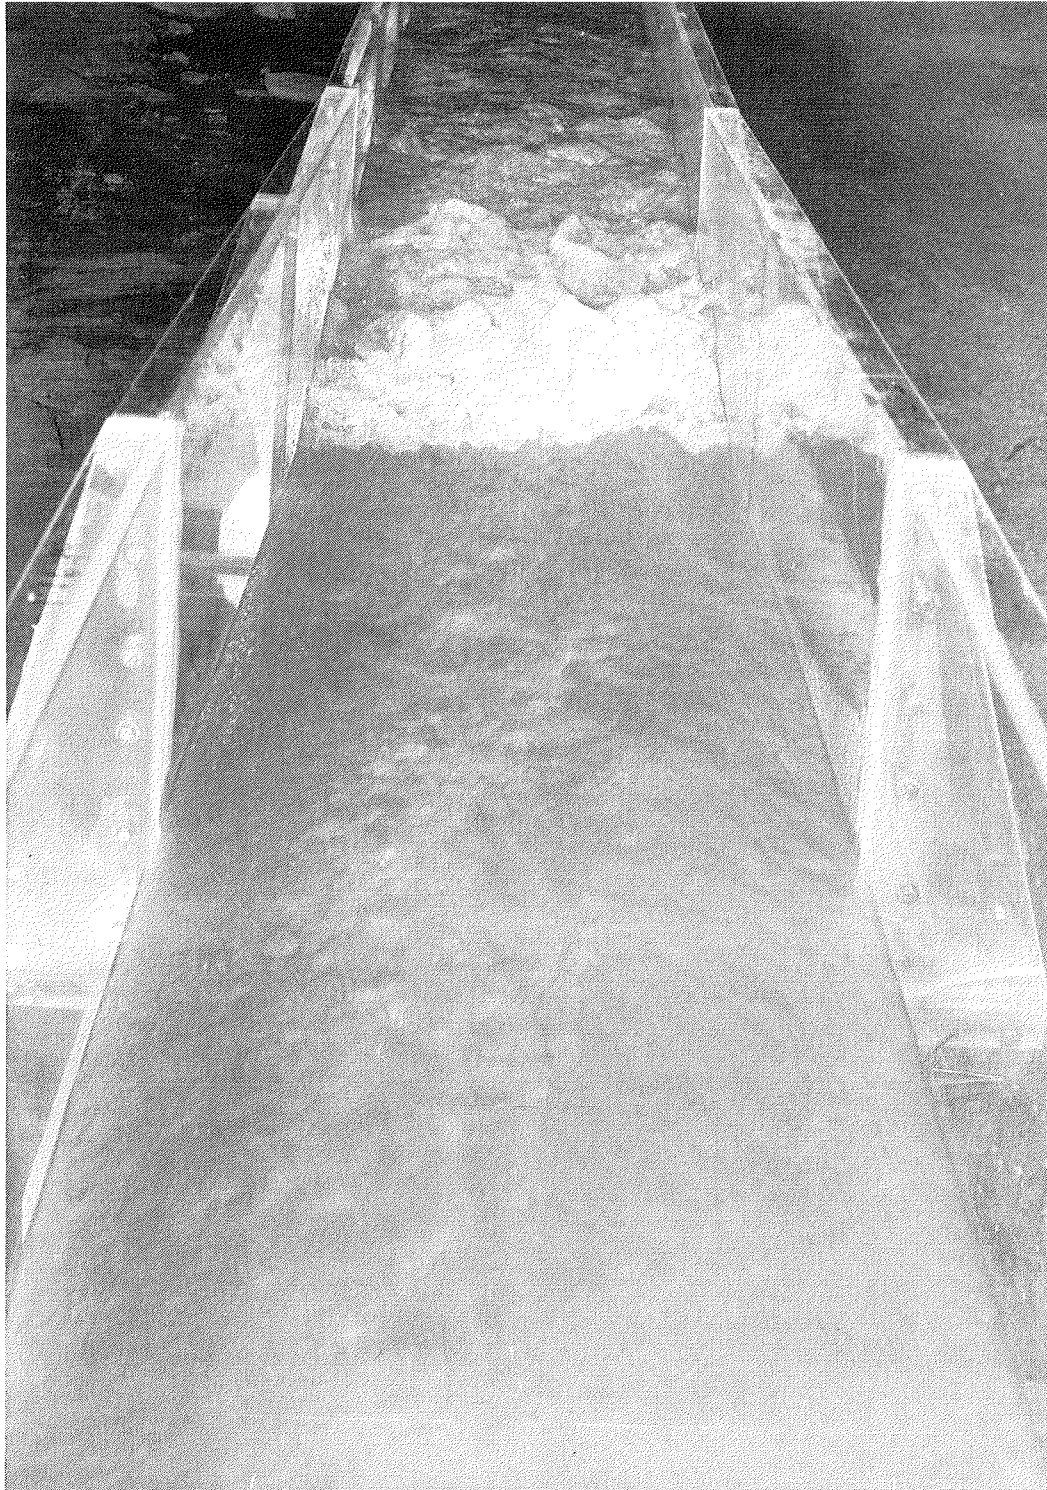
a. Overhead view looking downstream

Photo 21. Hydraulic jump (sta 15+50) due to grade
break, Josefina Channel, discharge 11,268 cfs,
 $n = 0.015$ (Continued)

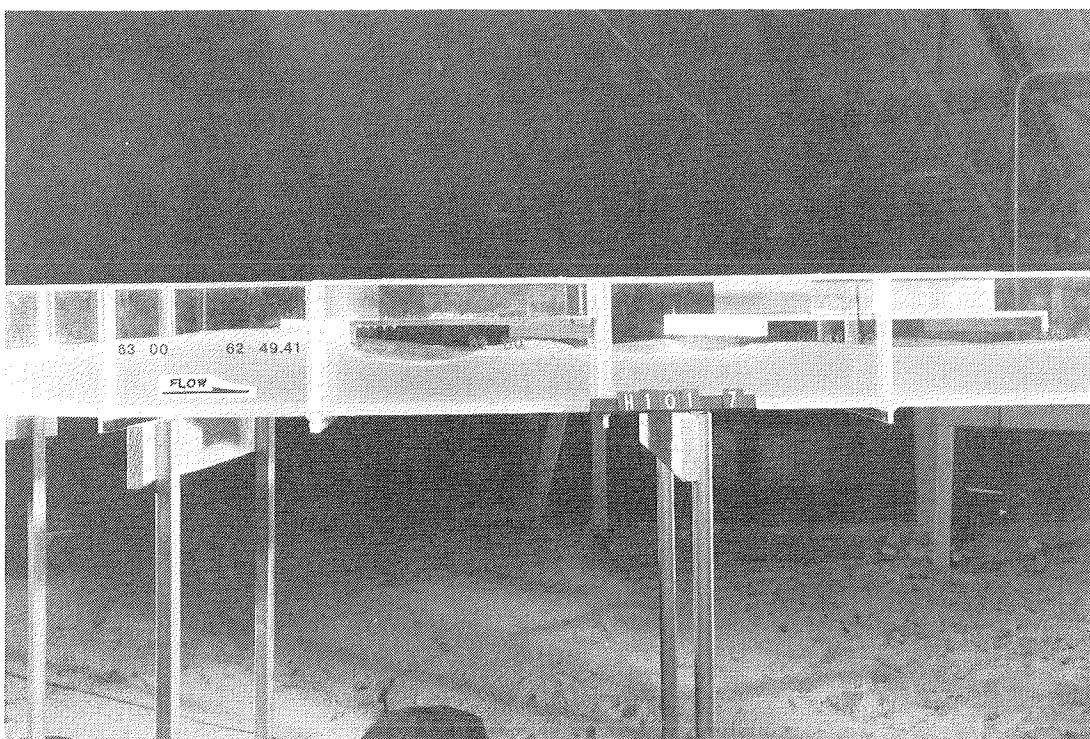
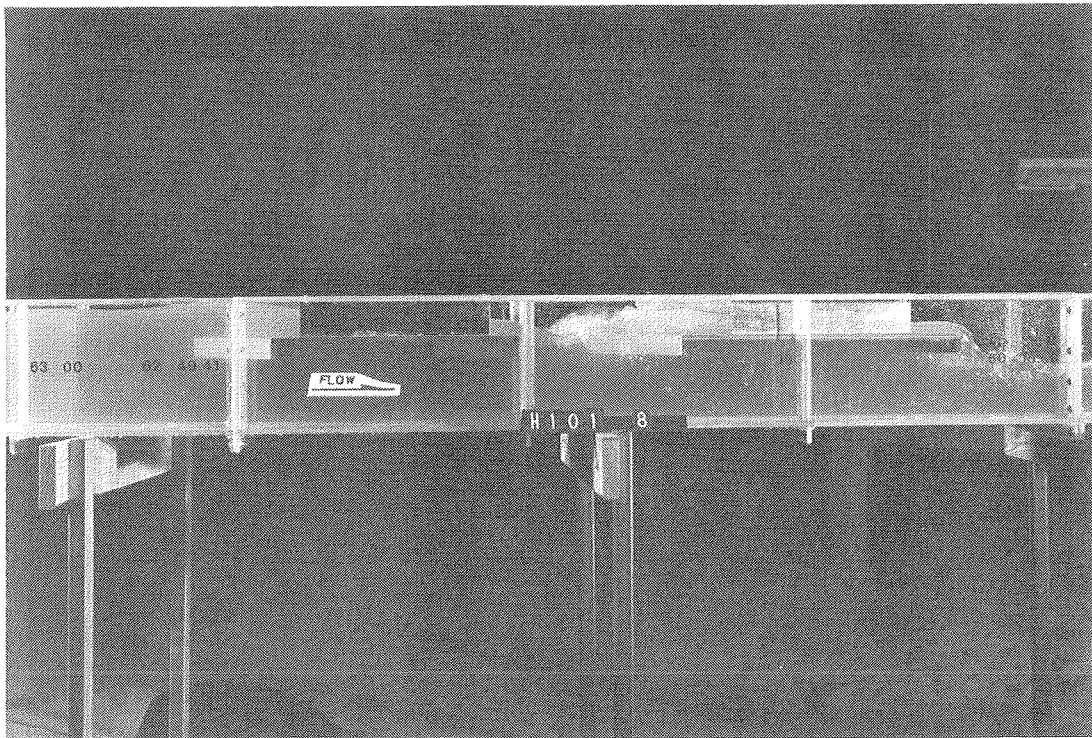
b. Discharge 11,200 cfs

Photo 22. Flow conditions at the De Diego Expressway Bridge (Continued)

c. Discharge 13,500 cfs

45. Flow conditions near the bridge with a discharge of 11,200 cfs are shown in Photo 22b. A wave developed upstream of the De Diego Expressway Bridge and moved downstream hitting the bridge causing an increase in the water surface upstream to sta 63+50. The flow then swept underneath the bridge for a short period until the wave redeveloped and hit the bridge, starting the cycle again. Flow in the downstream portion of the channel was still concentrated along the left bank.

46. The flow conditions near the bridge with a discharge of 13,500 cfs are shown in Photo 22c. The De Diego Expressway Bridge was submerged and flow in the channel upstream of the bridge in the model was subcritical. The flow

returned to supercritical flow at sta 60+25. Flow conditions were unsatisfactory with this discharge.

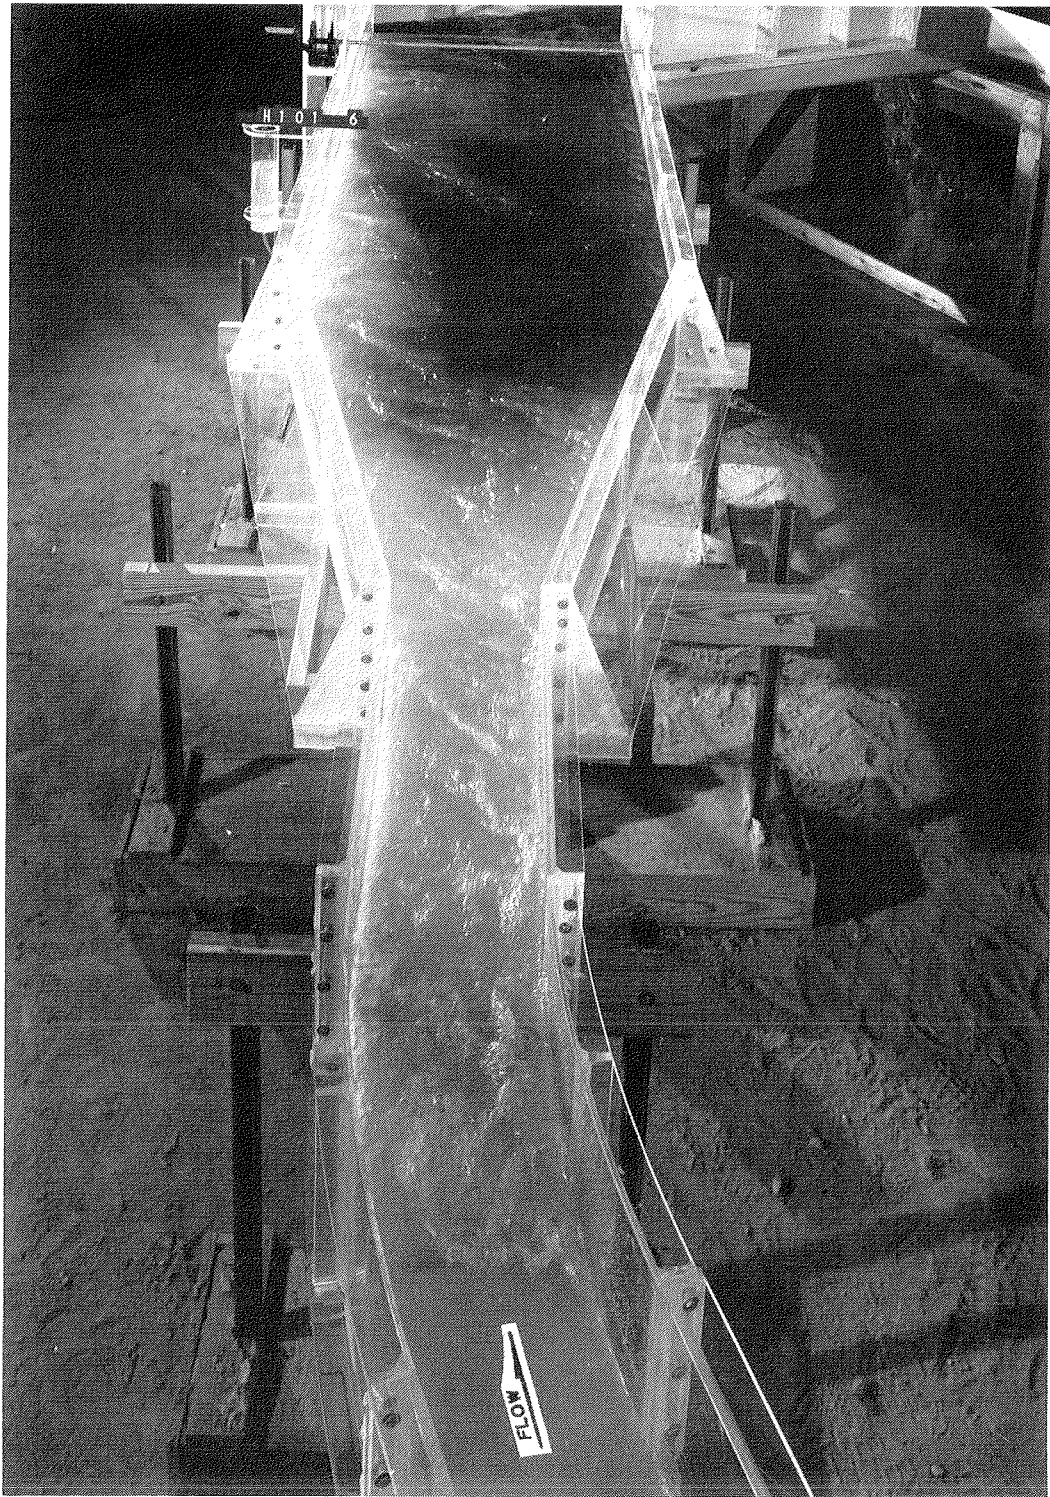
Photo 23. Flow conditions with the type 1 (original) design transition, discharge 8,800 cfs

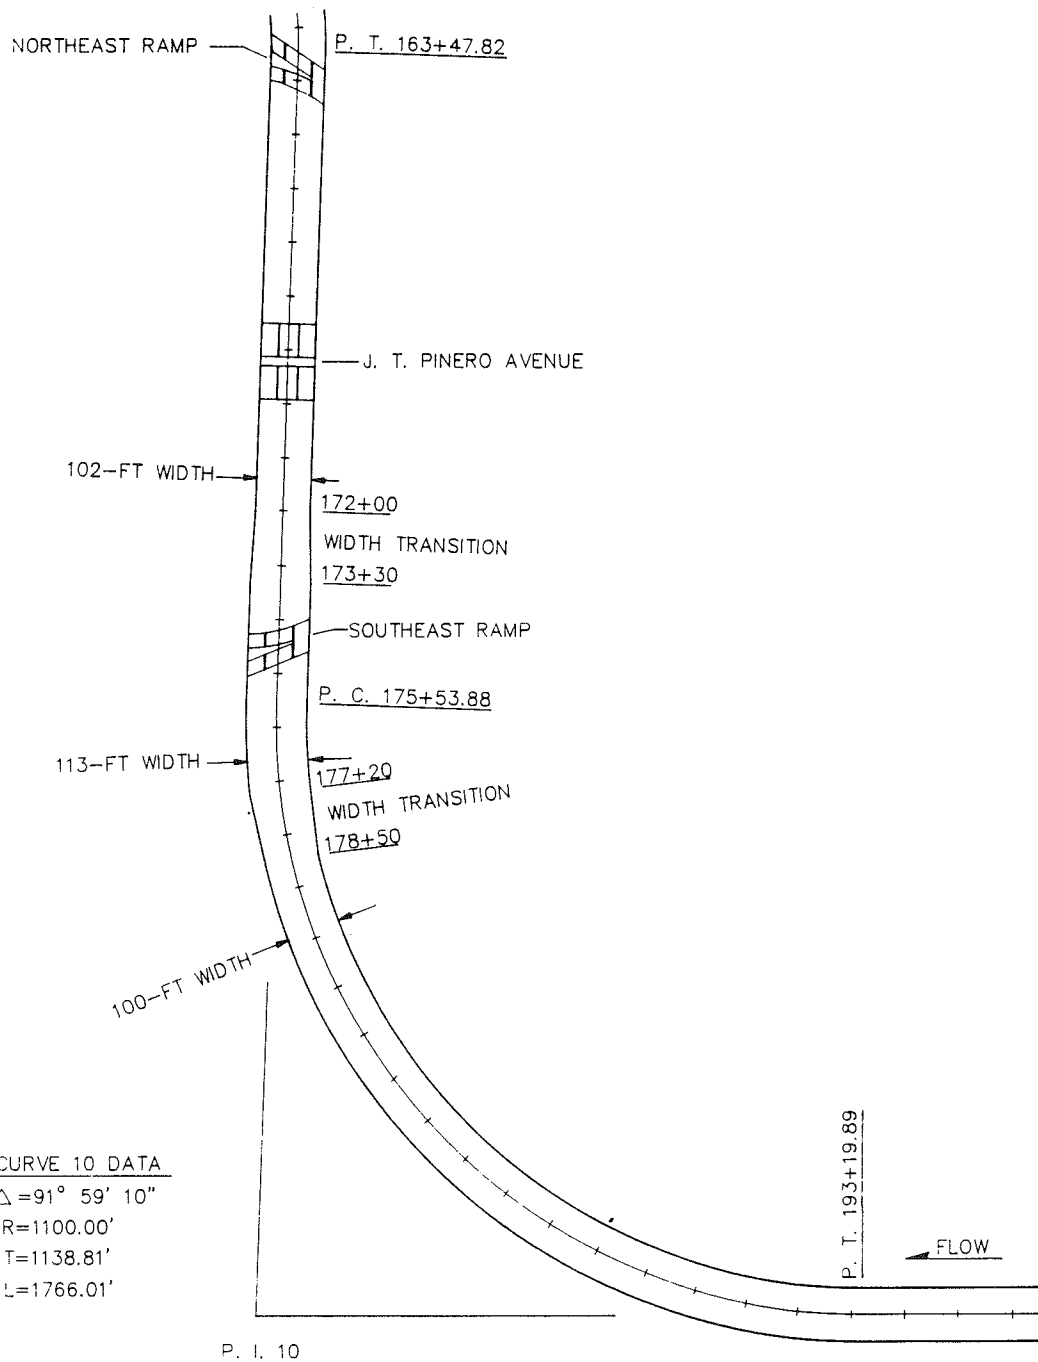
PUERTO NUEVO CHANNEL
 PLAN VIEW
 STA 163+00 TO 196+00
 TYPE 1 (ORIGINAL) DESIGN

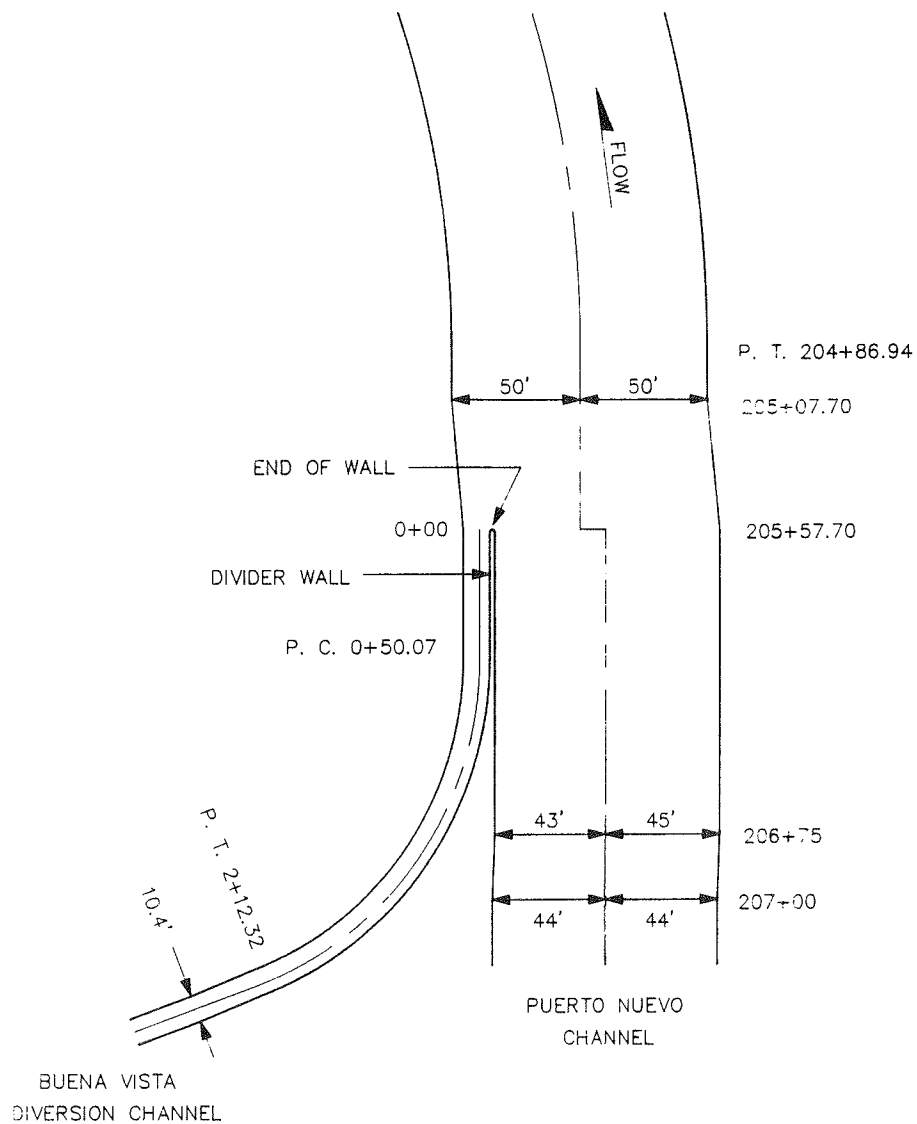
PUERTO NUEVO - BUENA VISTA
DIVERSION CONFLUENCE
TYPE 1 (ORIGINAL) DESIGN

14. In addition to the type 1 (original) design shown in Plate 17, four other confluence divider walls were tested. The details of these Puerto Nuevo/Buena Vista Diversion confluence walls are presented in Plates 18-21. The type 4 design confluence wall in conjunction with the type 2 design channel resulted in satisfactory flow conditions in the confluence vicinity

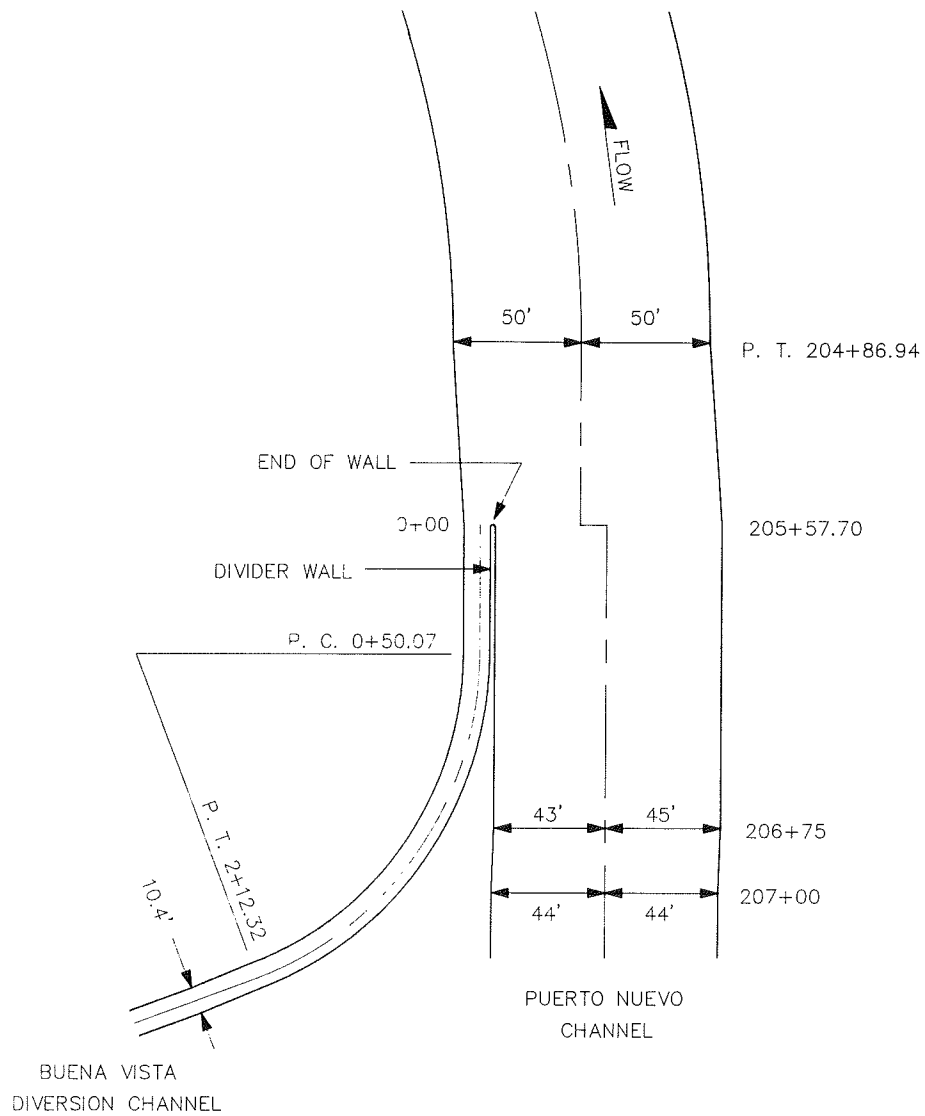
PUERTO NUEVO - BUENA VISTA
 DIVERSION CONFLUENCE
 TYPE 2 DESIGN CHANNEL
 WITH TYPE 1 DESIGN
 CONFLUENCE WALL

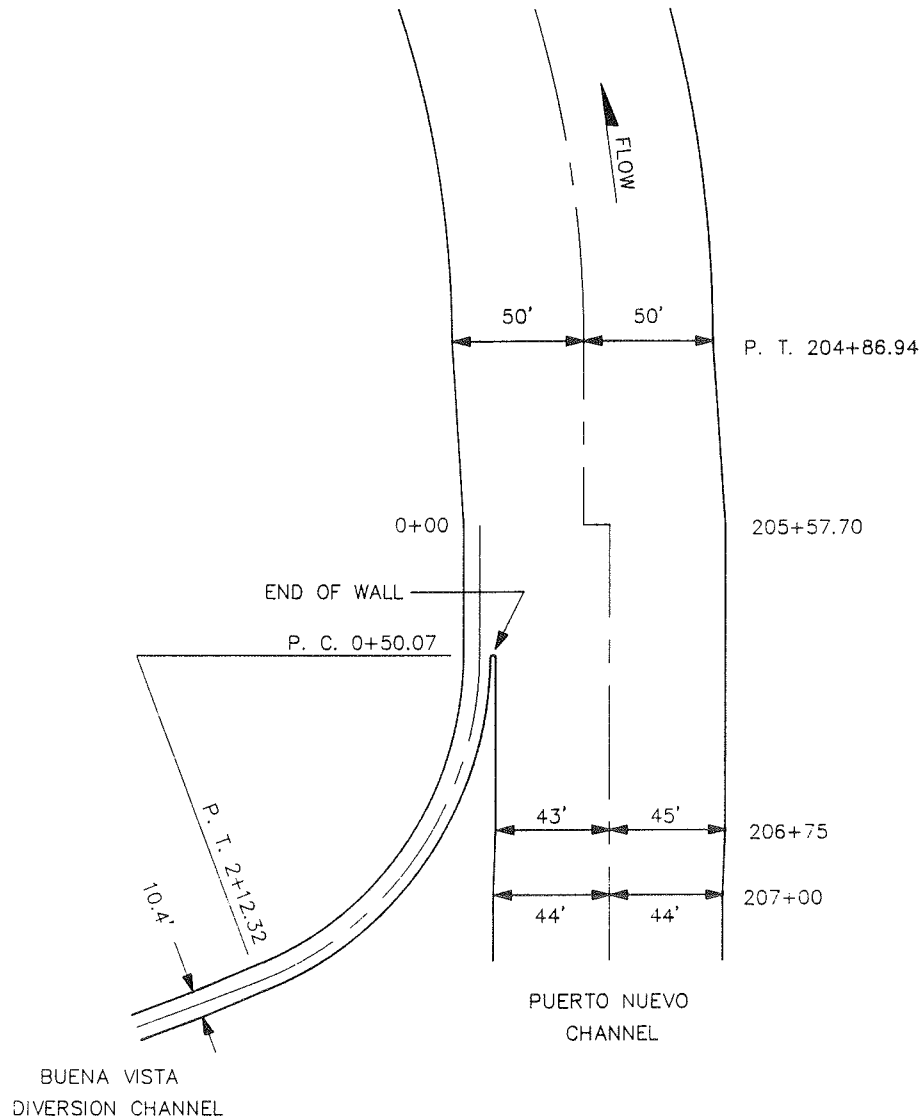
PUERTO NUEVO - BUENA VISTA
DIVERSION CONFLUENCE
TYPE 2 DESIGN CHANNEL
WITH TYPE 2 DESIGN
CONFLUENCE WALL

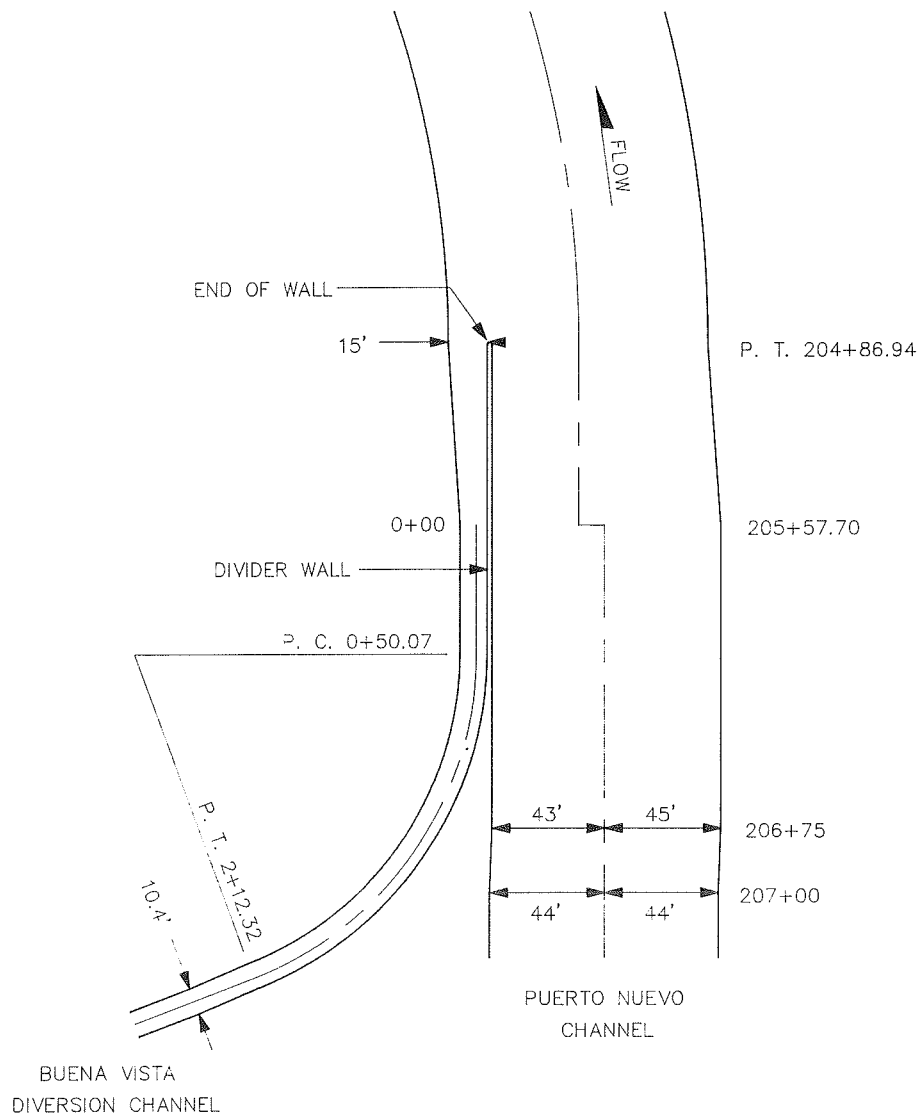
PUERTO NUEVO - BUENA VISTA
DIVERSION CONFLUENCE
TYPE 2 DESIGN CHANNEL
WITH TYPE 3 DESIGN
CONFLUENCE WALL

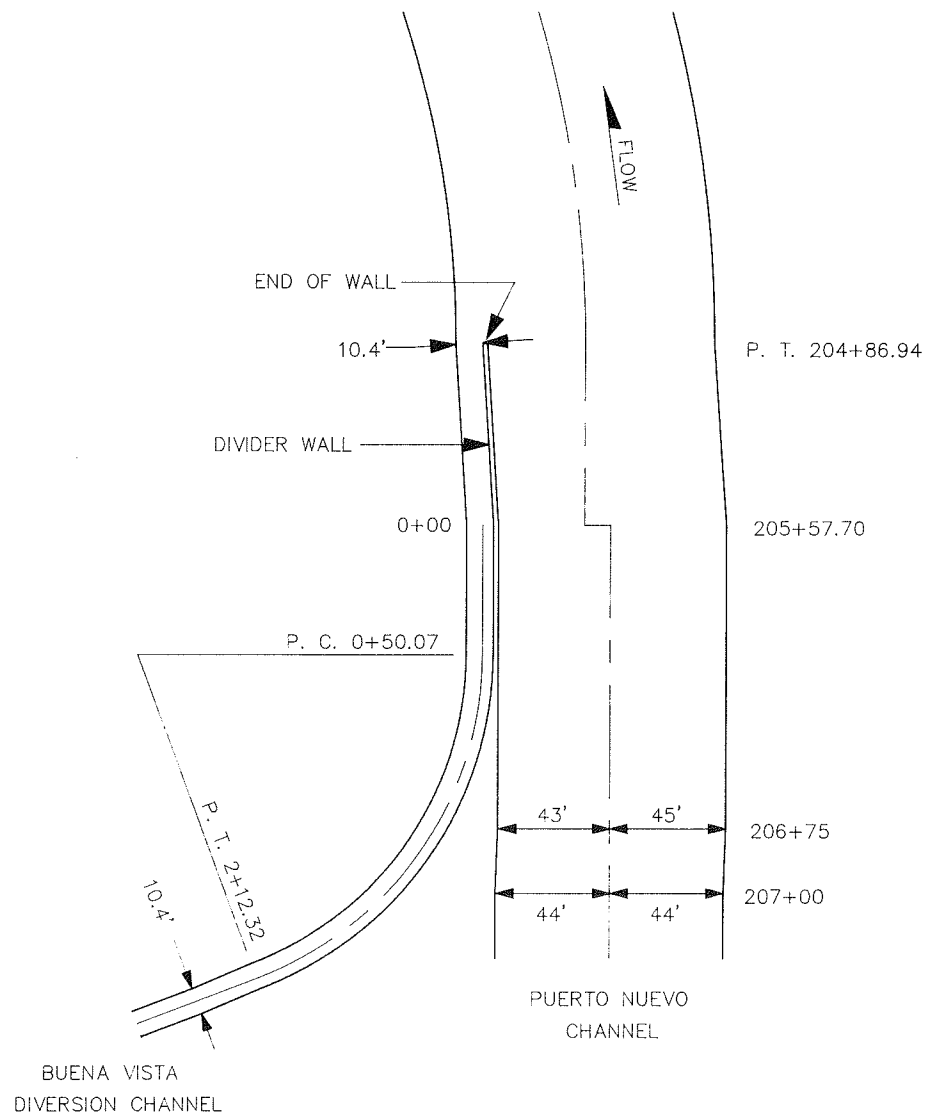
PUERTO NUEVO - BUENA VISTA
 DIVERSION CONFLUENCE
 TYPE 2 DESIGN CHANNEL
 WITH TYPE 4 DESIGN
 CONFLUENCE WALL

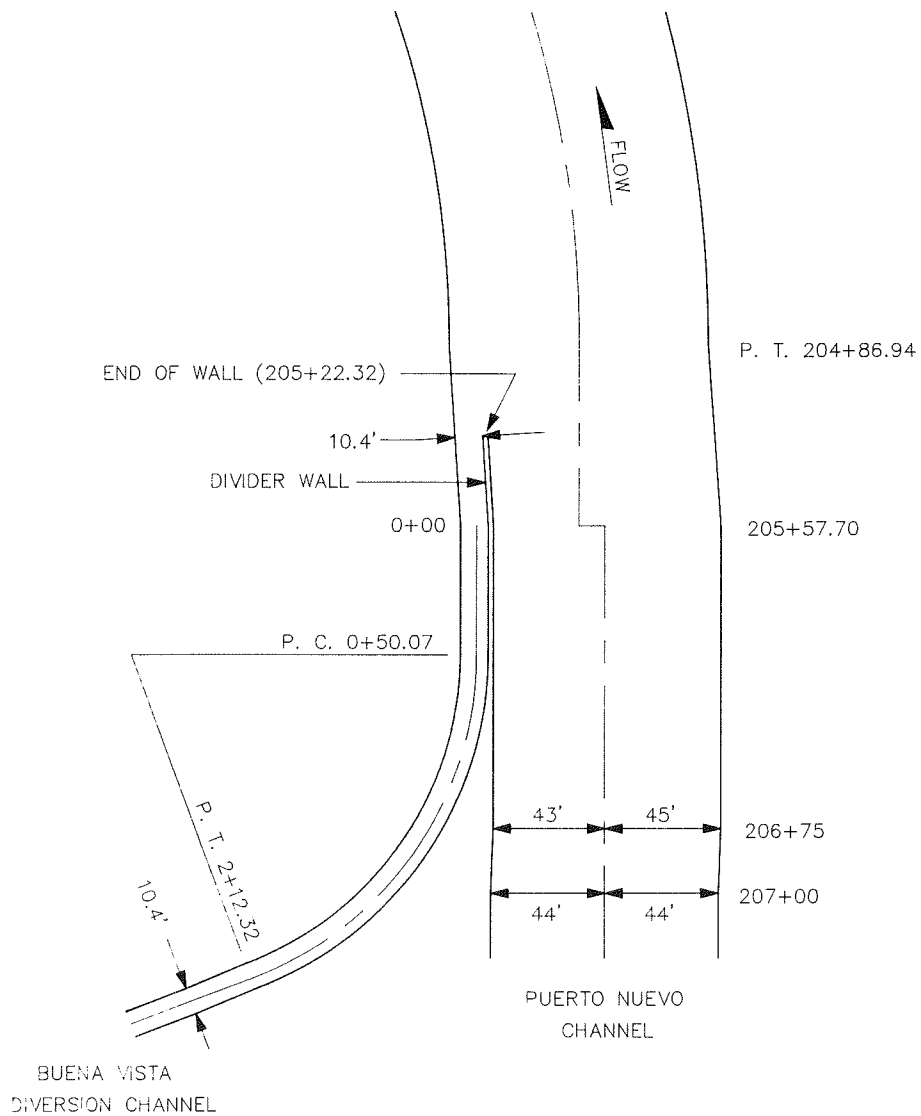
PUERTO NUEVO - BUENA VISTA
 DIVERSION CONFLUENCE
 TYPE 2 DESIGN CHANNEL
 WITH TYPE 5 DESIGN
 CONFLUENCE WALL

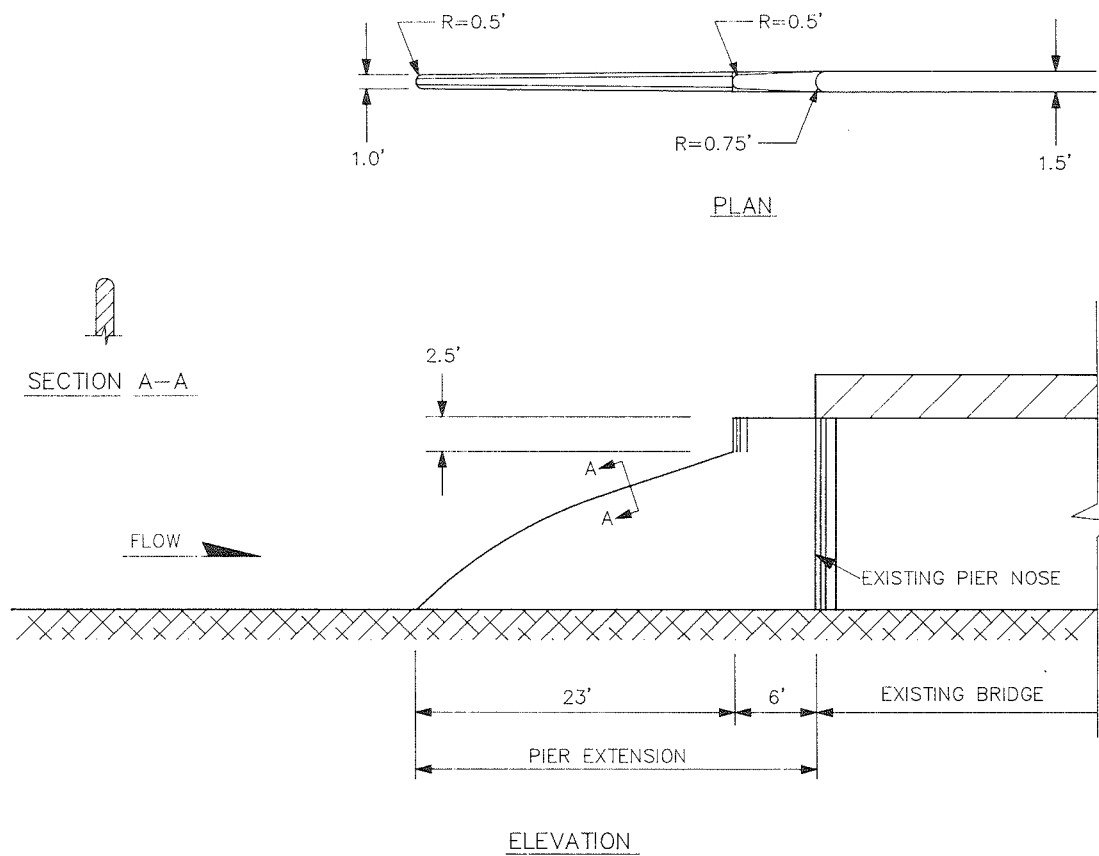
PUERTO NUEVO CHANNEL
PINERO AVENUE BRIDGE
TYPE 2 DESIGN PIERS

15. Tests involving bridge pier modifications were conducted in an attempt to increase the discharge capacities of the bridges. Modifications of the Pinero Avenue Bridge piers consisted of adding a debris nose to the upstream face of the piers as recommended in Engineer Manual (EM) 1110-2-1601* (type 2 design, Pinero Avenue piers, Plate 23). This modification would inhibit the accumulation of debris on the piers. Flow conditions with the type 2 design piers were similar to the type 1 (original) design with no debris accumulation on the bridge piers.

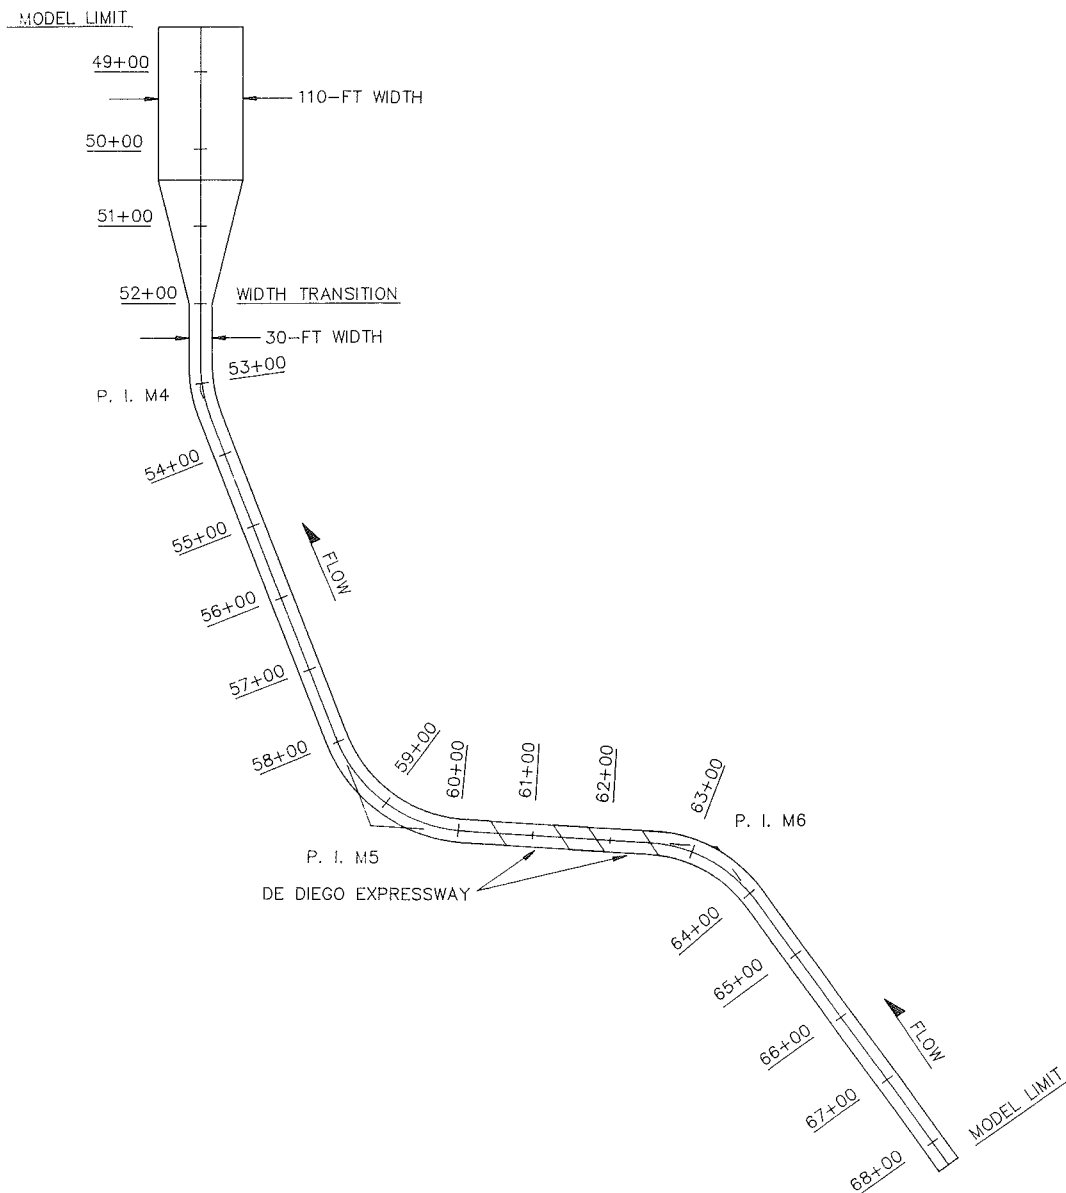
MARGARITA CHANNEL
PLAN VIEW
TYPE 1 (ORIGINAL) DESIGN

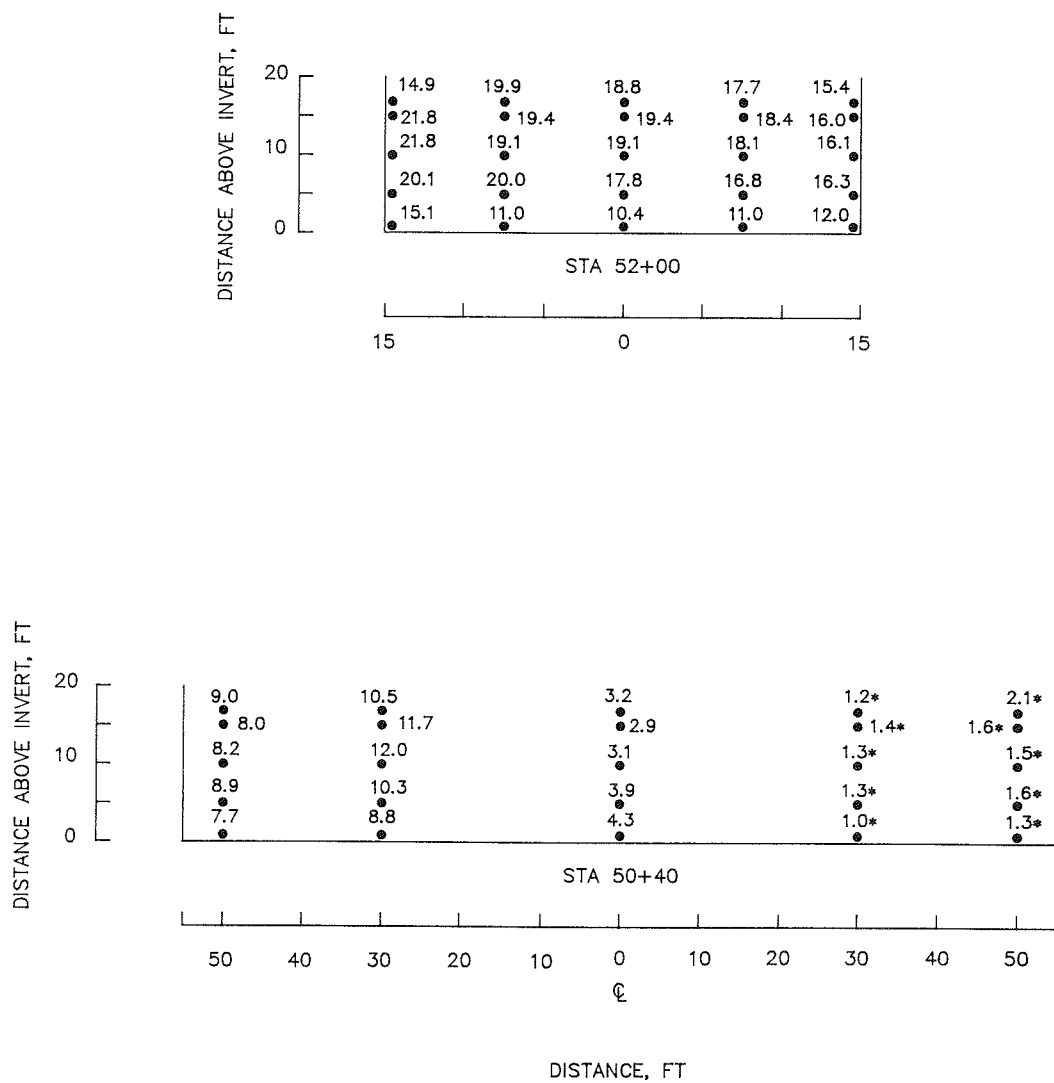
NOTE: VELOCITIES ARE IN FEET PER SECOND
 LOOKING DOWNSTREAM
 * VELOCITIES ARE IN UPSTREAM DIRECTION

VELOCITIES
MARGARITA CHANNEL
TYPE 2 DESIGN
 DISCHARGE 8,800 CFS

47. Modifications were made to the channel in an effort to improve the flow conditions in the transition between sta 50+20 and 50+40. Initially, baffle blocks were placed in the 30-ft-wide section of the channel. This was designated the type 2 design transition, shown in Plate 71. Flow conditions were improved over the original design, but were still considered unacceptable. Velocities measured at sta 52+00 and 50+40 with the type 2 design are shown in Plate 72.

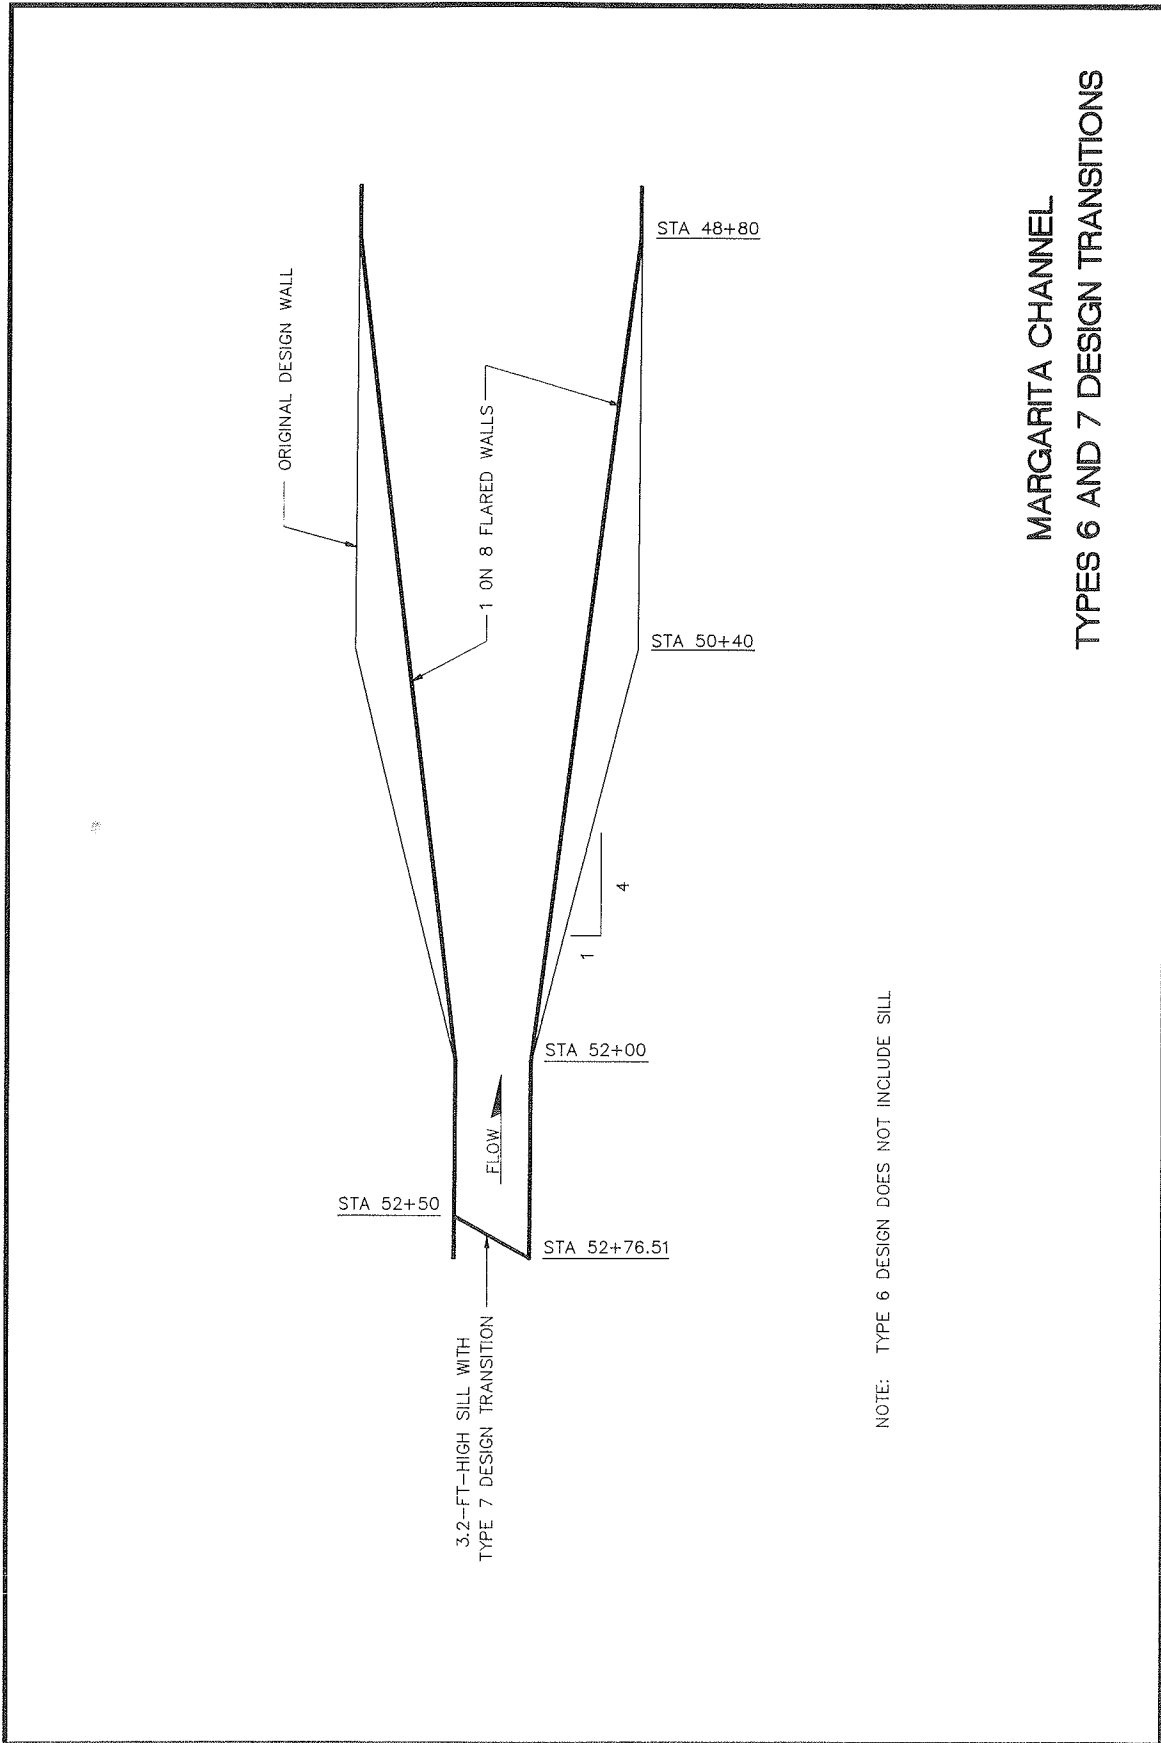
MARGARITA CHANNEL
TYPES 6 AND 7 DESIGN TRANSITIONS

49. Since the sills alone did not appear to be an effective modification, the transition flare was changed from 1 on 4 to 1 on 8. The type 6 design (Plate 74) was tested, and velocities measured at the end of the transition (sta 48+80) are provided in Plate 75. Flow conditions were improved over the original design (Plate 66), but were not as uniformly distributed as was observed with the type 3 design. The type 7 design (Plate 74) consisted of the 1 on 8 transition flare in addition to the sill arrangement used with the type 3 design. The velocities obtained with the type 7 design are shown in Plate 75. The flow conditions with the type 7 design were improved over previous modifications tested, but the flow was still not uniformly distributed in the channel.
